Manhole Inspection Summary

Manhole # S21MM_042MH

Insp Date: **7/3/07 9:33 AM**

Location Address: **2626 WOODBROOK AVE**

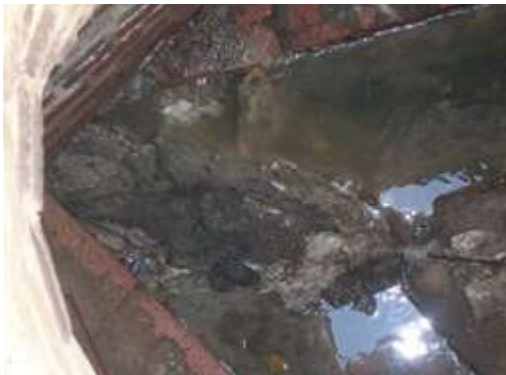
Defect 2

Condition: ☐ Sound ☐ Cracked ☐ Root Intrusion ☐ Deteriorated ☐ Leaks ☒ **Debris**

ALOT OF DEBRIS IN CHANNEL

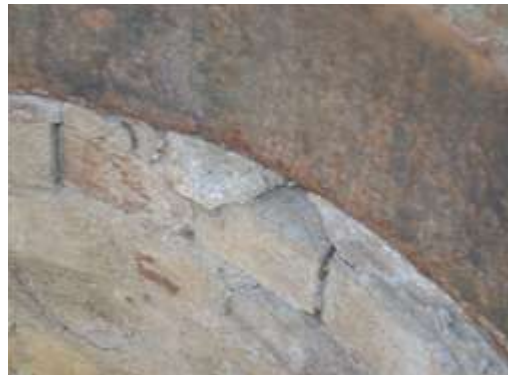
Defect 1

Condition: ☐ Sound ☐ Cracked ☐ Root Intrusion ☐ Loose Brick ☒ **Deteriorated**

DETERIORATION OF CHIMNEY

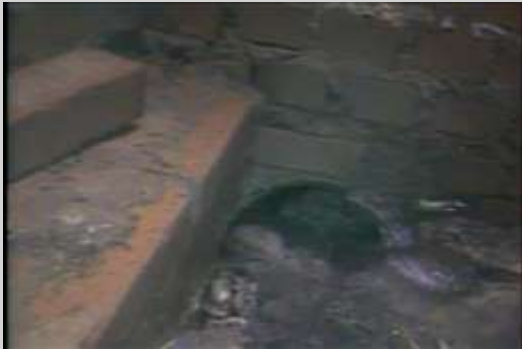
12 O'Clock Outflow

Pipe Height: **8.4** (in.) Rod and Bar (Angled)
Pipe Material: **Clay** ☐ Pipe Lined
Invert Depth: **8.55** (ft.) Flow Characteristics: **Slow**
Deposits: ☐ None ☐ Mud ☐ Sludge ☒ **Debris** ☐ Grease
Silt Depth: **4** (in.) Deposits Extent: **Heavy**
Infiltration: **None** Pipe Seal Cond: **Sound**

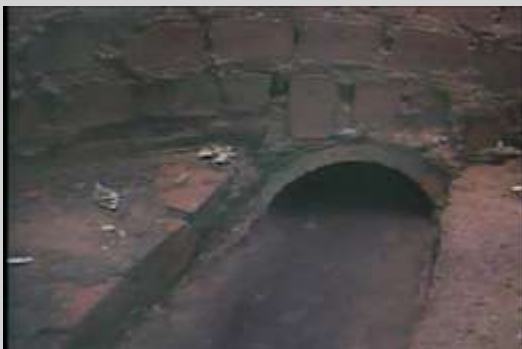
3 O'Clock Inflow

Pipe Height: **10.8** (in.) Rod and Bar (Angled)
Pipe Material: **Clay** ☐ Pipe Lined
Invert Depth: **8.39** (ft.) Flow Characteristics: **Slow**
Deposits: ☐ None ☐ Mud ☐ Sludge ☒ **Debris** ☐ Grease
Silt Depth: **2** (in.) Deposits Extent: **Light**
Infiltration: **None** Pipe Seal Cond: **Sound**

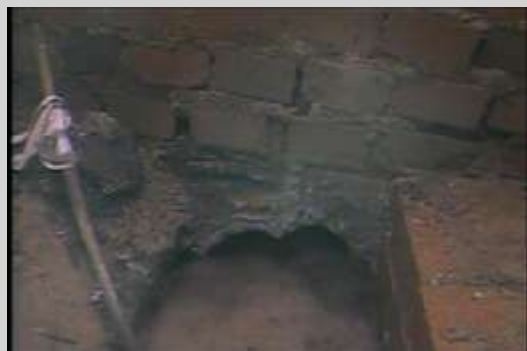
6 O'Clock Inflow

Deposits: ☐ None ☐ Mud ☐ Sludge ☒ **Debris** ☐ Grease

Silt Depth: **2** (in.) Deposits Extent: **Light**
